Technical Note N- 1134

THE SPHERICAL ACRYLIC PRESSURE HULL FOR  
HYDROSPACE APPLICATION: PART IV - CYCLIC  
FATIGUE OF NEMO CAPSULE #3

J. D. Stachiw

NAVAL CIVIL ENGINEERING LABORATORY  
Port Hueneme, California 93041

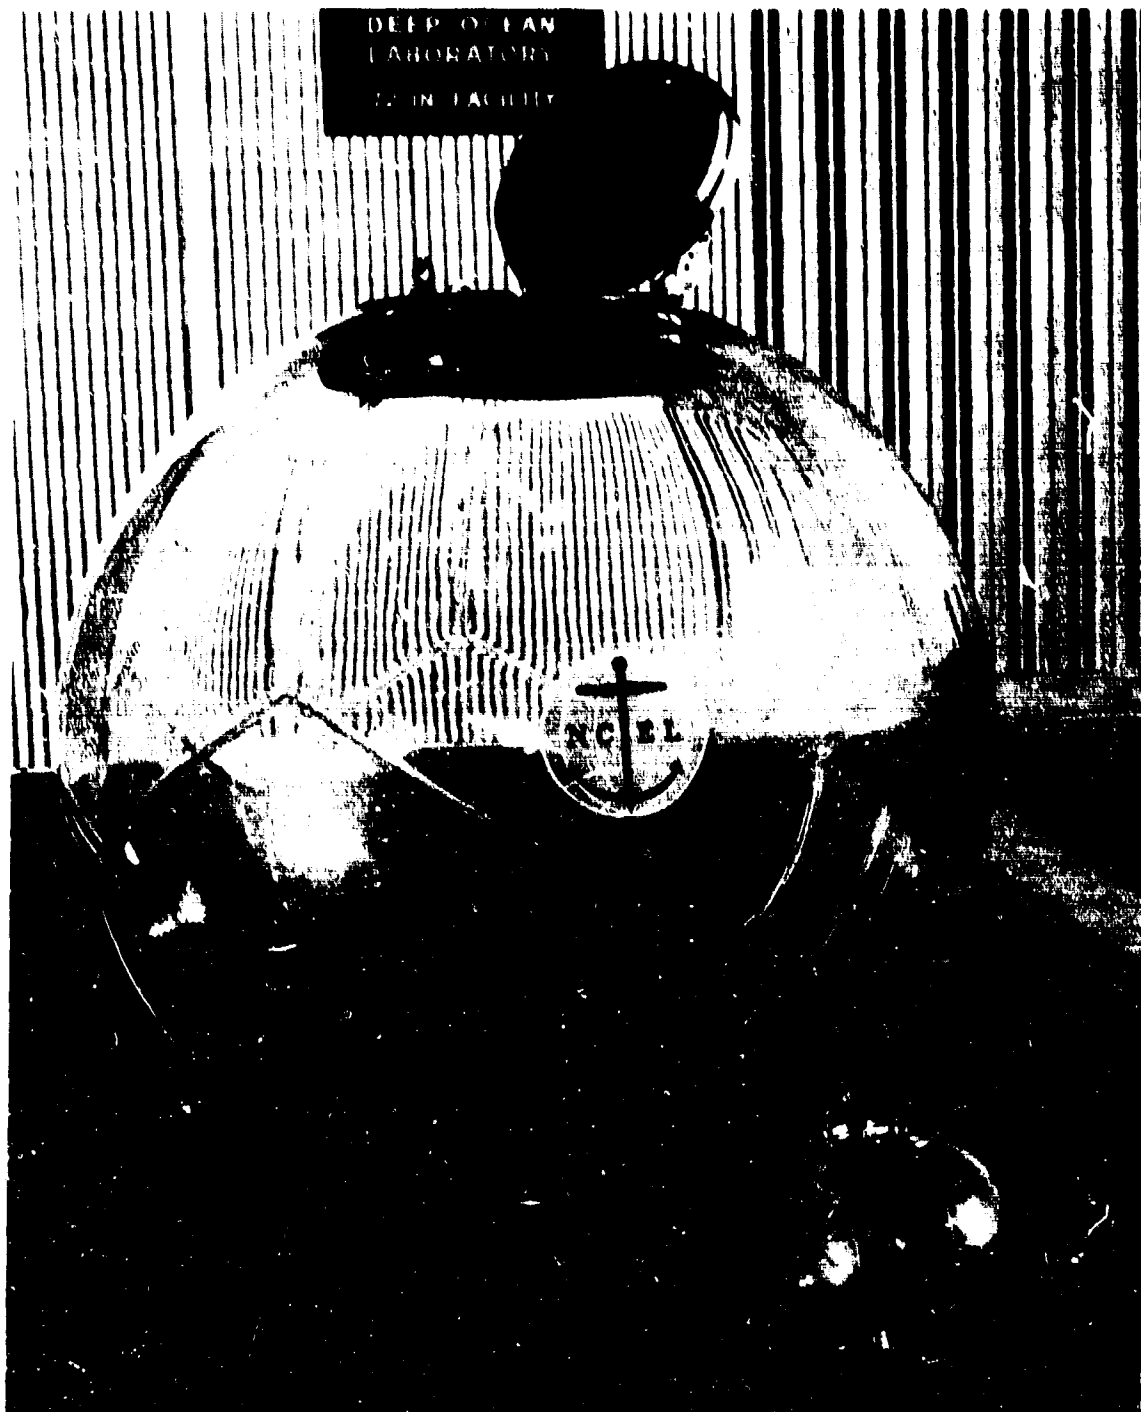
Figure 1. NEMO Model 600 capsule with hull #3; 15-inch NEMO model is shown for scale.

NEMO Model 600 hull #3 served as the test specimen (Figure 1). The construction of hull #3 (Tables 1 and 2) was very similar (Figures 2 through 8) to that of hull #0 imploded previously<sup>1</sup> at 4150-foot depth during the full-scale NEMO hull development tests. The only significant difference between hull #3 built by Swedlow Inc. together with hulls #1 and #2 (Appendix A) and hull #0 built by the Pacific Missile Range was the use of different adhesive and steel alloy for the polar penetration closures (Figure 8).

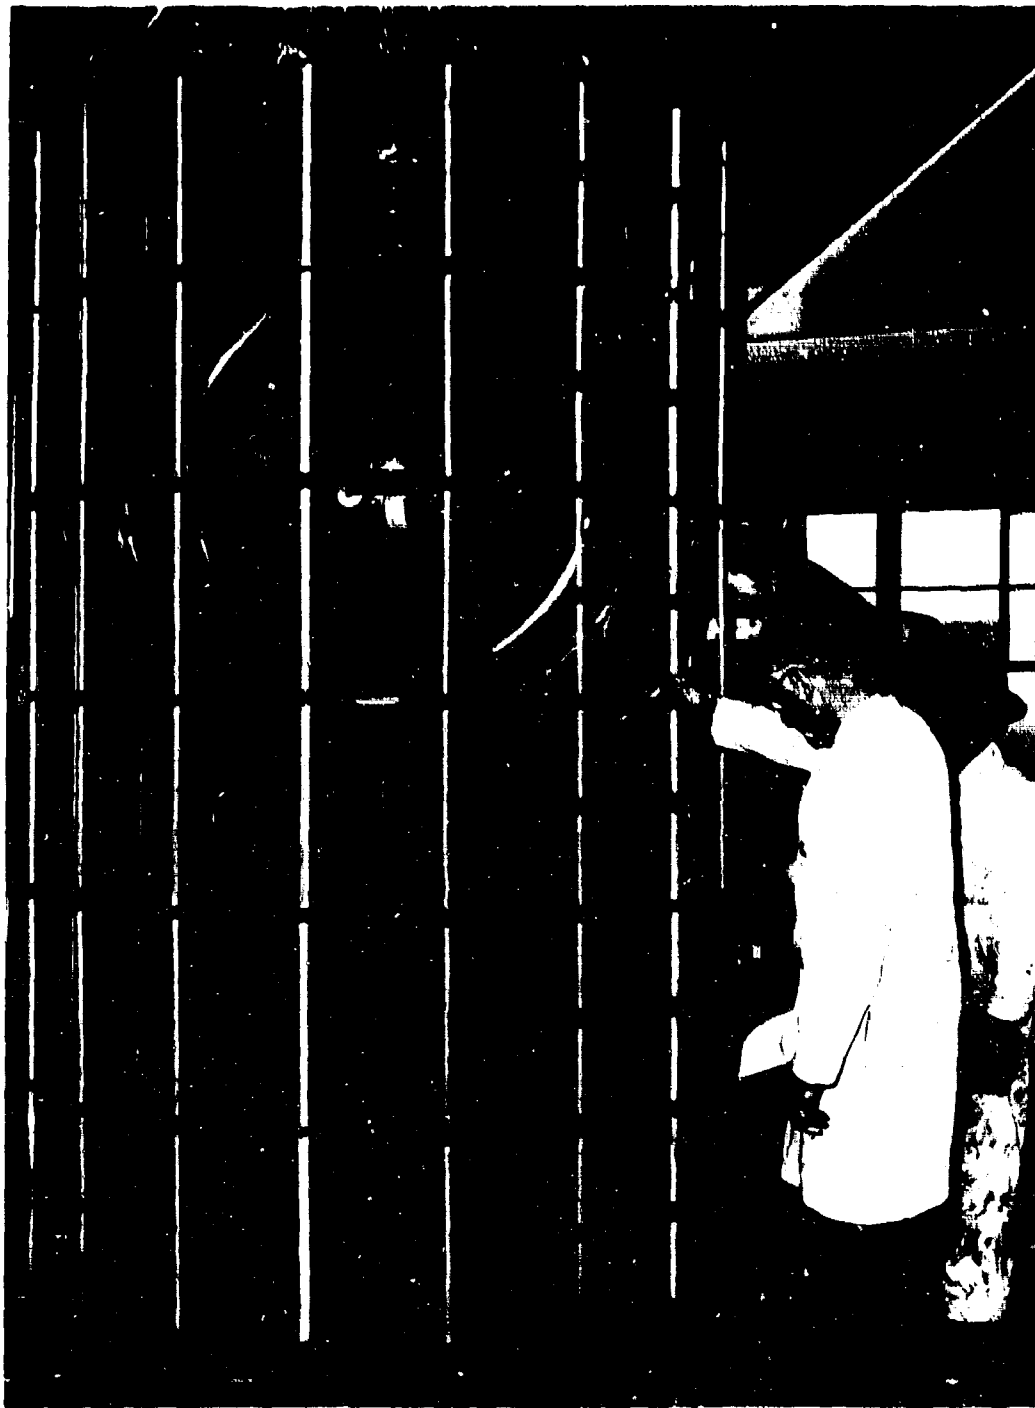
Figure 9. Jig for hydrostatic testing of NEMO Model 600 in NCEL's 72-inch diameter Deep Ocean Simulator.

The same test arrangement was used for hull #3 as was previously used for hydrostatic testing of hull #0 (Figure 9). The assembled hull was placed inside a cage-like test jig and was fastened to it by bolting the bottom penetration plate to the support pedestal integral with the cage. Since hull #3 was not filled with water for the tests, the bottom plate had to resist 4000 lb upward pull when the cage assembly was placed in the water-filled 72-inch diameter pressure vessel.

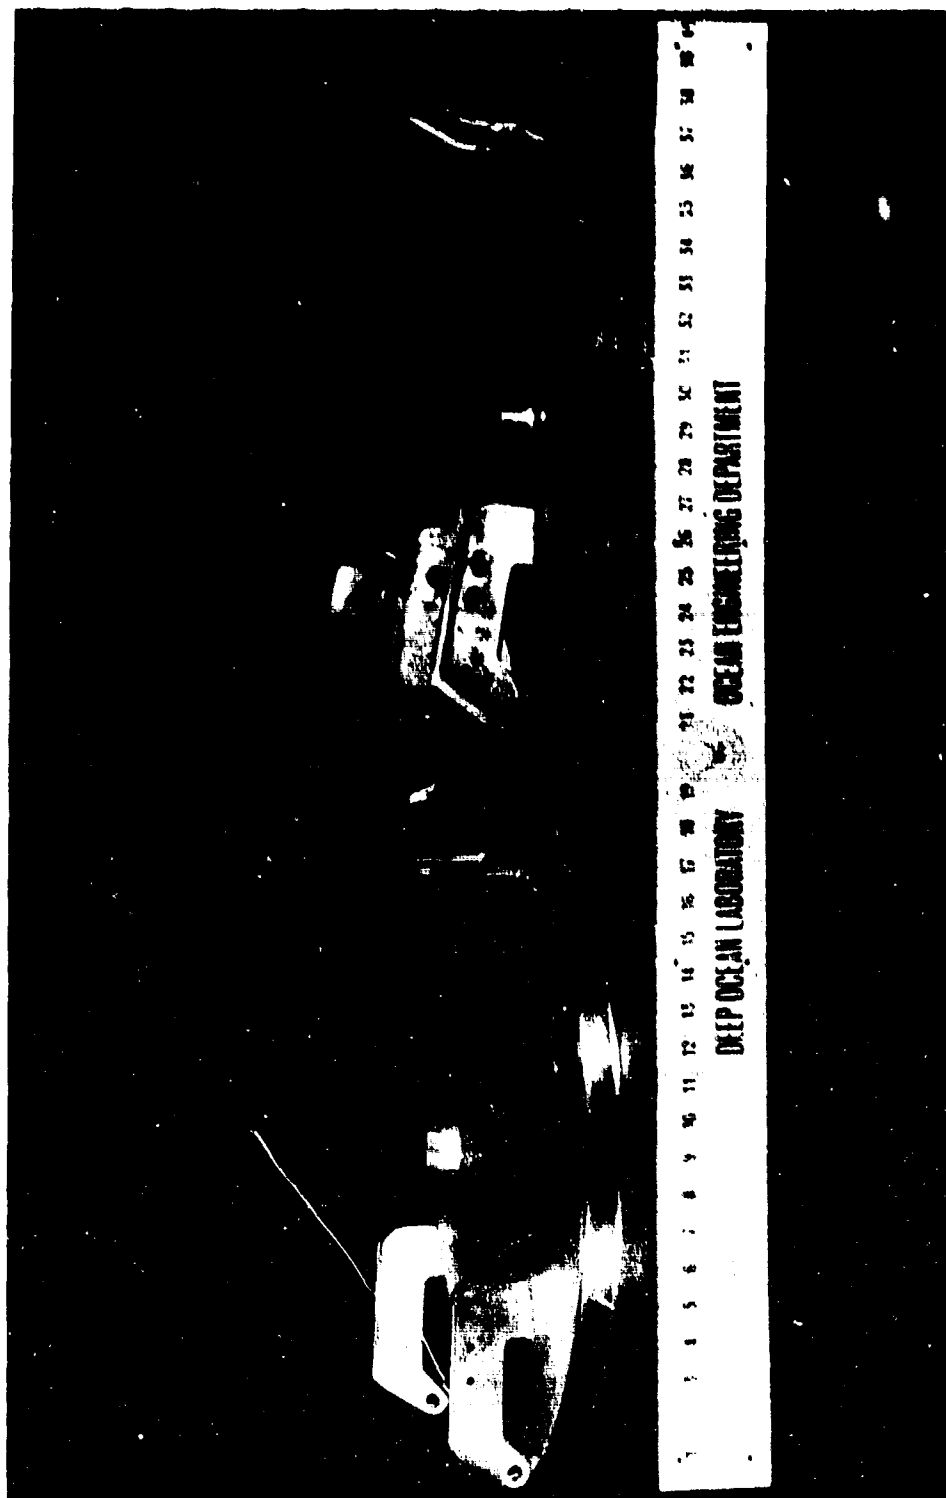
The top hatch exhibited typical plastic buckling of sufficient magnitude to result in complete reversal of hatch curvature (Figure 18). Where previously the hatch was convex, now it is concave. No cracks were observed in the plastically buckled hatch and the cadmium plating did not spall off from the yielded steel.

Figure 18. Comparison between the plastically buckled and a brand new hatch of annealed 4130 steel for NEMO Model 600 capsule.

The hatch in the NEMO Model 600 possesses a safety factor of 3.8 based on the relationship between the 2250-foot depth where plastic buckling of 4130 annealed steel hatch occurs after repeated dives, and the 600-foot maximum operational depth.

When future NEMO Model 600 pressure hulls with 4130 steel end-closures are built, the minimum yield strength of the 4130 steel alloy could be increased, if so desired, to 130,000 psi by heat treatment to eliminate plastic buckling of the hatch prior to general implosion of the acrylic hull at 1850 psi.
